Property Inspection Report

1234 Main Street
Hometown, Ohio

People Present Client, Client's Realtor Property Occupied No
Building Type Single Family
Year Built 1969 Entrance Faces West
Inspection Date 10/30/2018
Start Time 9:00 AM
Temperature 65 Degrees
Weather Partly Cloudy Soil Conditions Damp Period

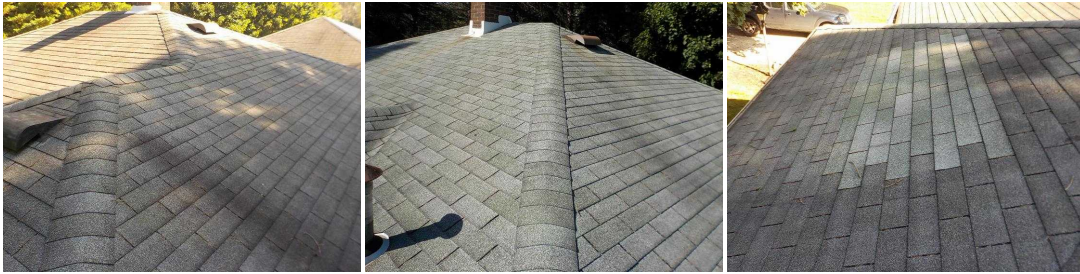
Major Repairs Material: Asphalt/Fiberglass Shingles - The roof covering is generally showing heavy wearing and extending past its typical life. Some heavy sanding has occurred and there are two missing shingle tabs. If leaks are not occurring at this time, it is in a condition where leaks could develop. We suggest further review by a roofing contractor. Due to age and wearing visible, roof replacement may be needed.

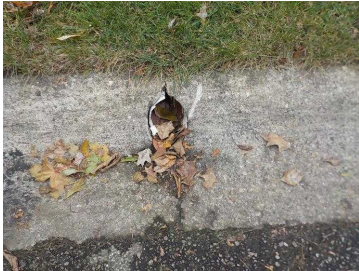
Maintenance Downspout Drainage: Underground Pipes - There are underground drain exits visible at the curb/street. Maintain as needed so water flows properly.

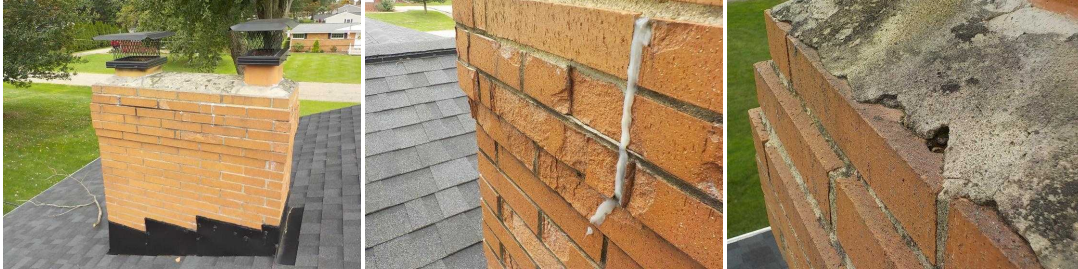
General Repairs Chimney: The concrete cap on the top of the chimney has cracking/deterioration. Suggest sealing the cracks or patching the concrete cap as needed to help prevent water entry and damage to the top of the chimney. Some spalling has occurred to brickwork at the top of chimney. This is likely caused by water entering and flaking off the front surface of the bricks. The brickwork could be patched/sealed as needed.

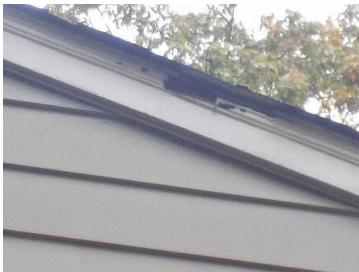
General Repairs Trims: **There is rotting/deterioration to the fascia board on the south side of the house. Animals/birds could enter. Suggest repairing as needed.**

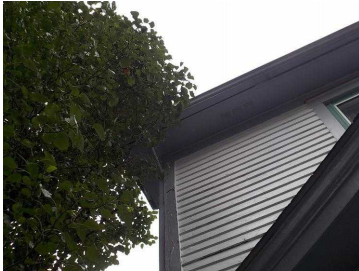
Maintenance Vegetation: There are trees near the structure. Suggest keeping leaves/debris cleaned off of the roof, out of the spouting system, and away from the foundation. There are tree limbs overhanging the chimney. This may restrict proper drafting. The trees could be trimmed as needed.

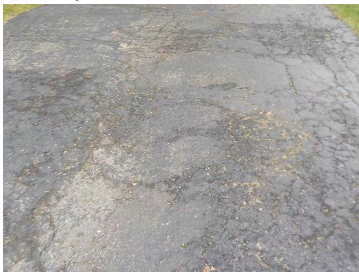
Maintenance Driveway: Asphalt - The asphalt drive is showing general cracking and deterioration. Suggest sealing to help extend the life.

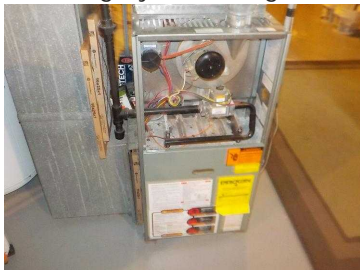
Maintenance Heating System Operation: The heating system is generally showing typical wearing for its age. When the thermostat was activated, the system appeared to respond normally. Suggest annual servicing by a heating contractor.

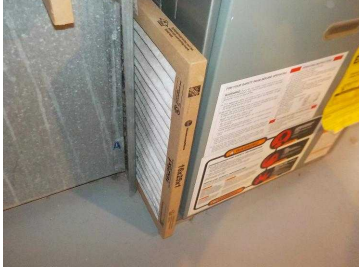
Maintenance Filter: Standard - Suggest checking the filter regularly and replacing/cleaning as needed.

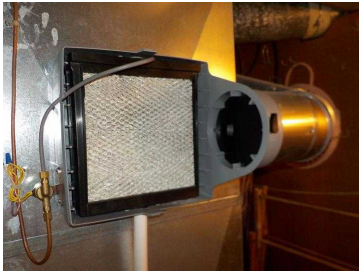
Maintenance Humidifier: The humidifier generally appears in functional condition at this time. A humidifier should be cleaned/serviced before each heating season. If not regularly maintained, water can leak into the furnace and cause damage and the unit can allow mold to grow.

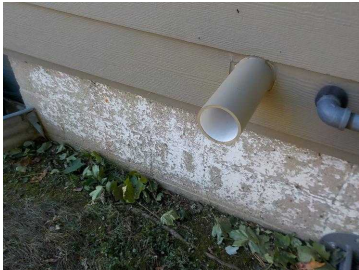
Monitor Flue Pipe: The heating system is a high efficiency type and vents out the wall of the house. Monitor for proper operation.

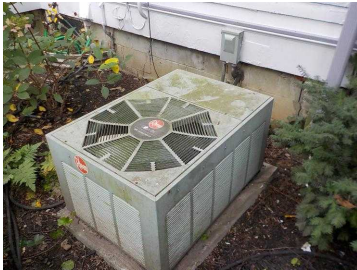
Maintenance A/C System Operation: The cooling system is generally showing typical wearing for its age. When the thermostat was activated, the system appeared to respond normally. Air exiting registers appears to have a proper temperature drop. Suggest annual servicing by a cooling contractor.

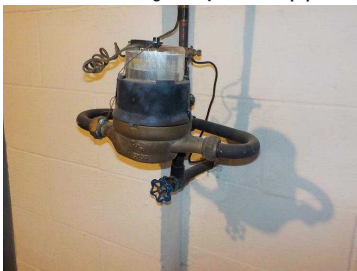
Satisfactory Water Entry Pipe: Copper

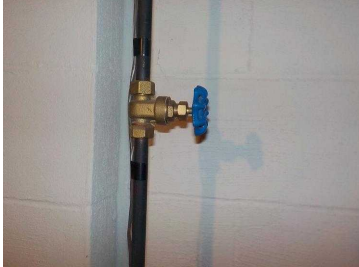
Maintenance Main Water Shutoff: The main shutoff is older and could be updated as needed.

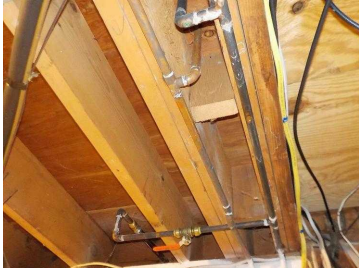
Monitor Supply Pipes: Original, Copper - Minor liming/corrosion evident at some of the joints and valves. The piping visible generally appears in functional condition at this time. Monitor.

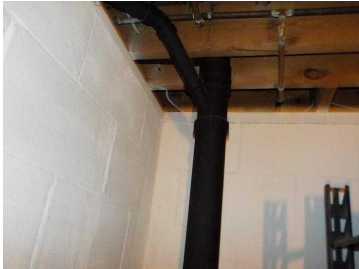
Monitor Drain Pipes: Mixture of original and newer, Plastic, Metal - The drain piping generally appears in functional condition. Monitor as it ages.

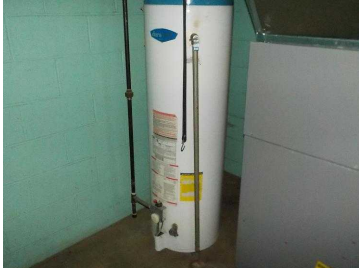
Maintenance Water Heater Operation: Generally showing typical wearing for its age. See approximate age and design life listed above. The tank appears to be operating properly at this time. Maintain as needed.

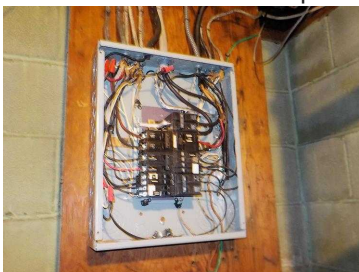
Maintenance Panel Condition: Original, Breakers - The panel appears professionally installed and in functional condition. Monitor. The panel is not completely labeled. Suggest labeling all circuits.

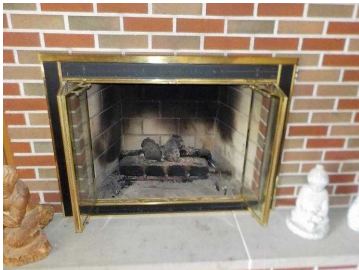
- Type: Wood Burning, Gas log
- Maintenance Flue: There is minor soot/creosote build up in the fireplace, smoke chamber, and chimney. Suggest it be cleaned by a chimney sweep and the chimney interior further inspected.
- Satisfactory Hearth:
- Monitor Fireplace: There are minor cracks in the firebox brickwork. Monitor for changes.

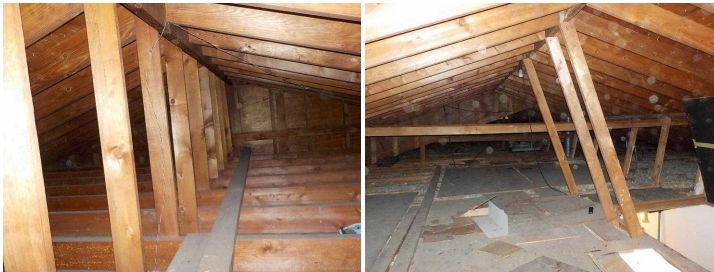
Monitor Roof Framing: Trusses, Plywood Subroofing - The roof framing and subroofing visible generally appeared in sound condition at this time. Monitor.

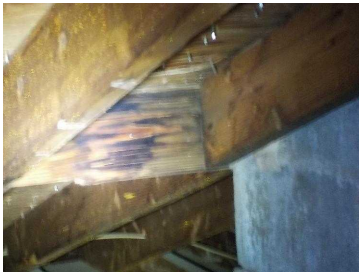
Monitor Moisture Penetration: There are water stains on framing around the chimney area. The stains were not wet at this time considering the recent rains. Suggest monitoring.

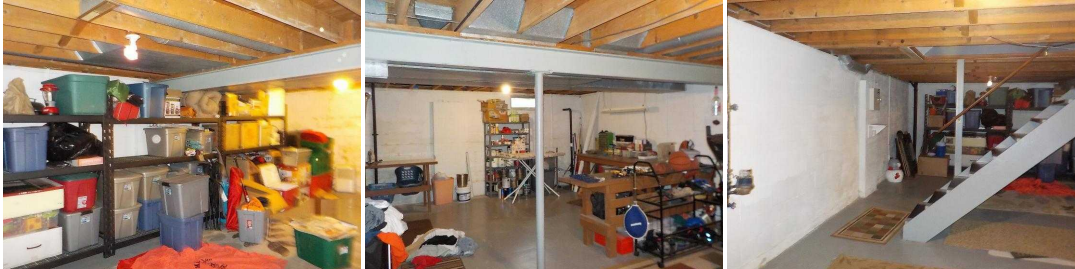
Monitor Foundation: Concrete Block - The structural inspection was limited due to: stored items. Some settling/cracking is common in any structure. Visible cracking/movement appeared typical for the age of the property. Monitor for further movement.

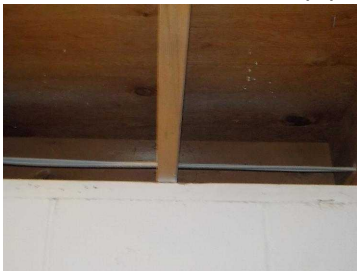
Monitor Floor/Slab: Concrete - There are minor/typical cracks in the basement floor. Suggest monitoring.
 Monitor Joists/Trusses: Standard Joists - The framing generally appears functional and adequate to support the loads. Suggest monitoring.
 Satisfactory Beams/Posts: Steel/Steel
 Satisfactory Subfloor: Plywood
 Maintenance Stairs/Railings: Ideally, basement steps should have handrails with proper spindles for safety of children. The current railing do not meet these standards and could be updated.
 Satisfactory Basement Windows: Glass Block
 Maintenance Insulation: Perimeter Joist - The perimeter joist spaces in the basement are not insulated. Insulation could be installed to help prevent heat loss from the basement.

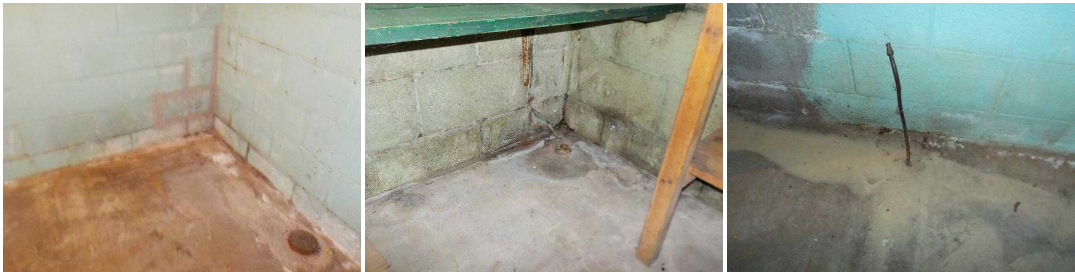
- Major Repairs Moisture: **The inspection for wetness in the foundation was limited due to: stored items, finishes, disclosure sheet not available, owner not available to question, not being an excessively wet period. There are stains evident on the foundation walls that indicates water leakage may be occurring. Improvements to the spouting drainage, ground drainage, and keeping up with exterior maintenance may help reduce this. However if a completely dry foundation is desired, a professional waterproofing system may need installed. Suggest further review by a waterproofing company.**

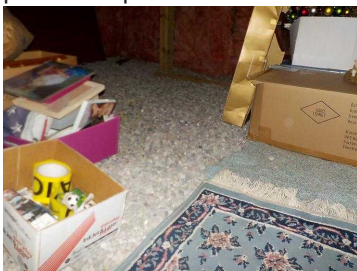
Maintenance Crawl Space Floor: Gravel - The floor in the crawl space is gravel. We suggest installing a heavy plastic vapor barrier over the crawl space floor to help prevent moisture penetration.

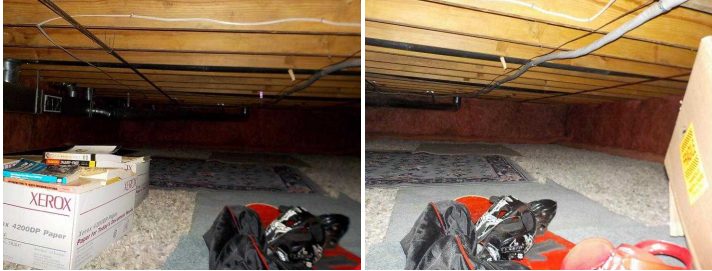
Monitor Crawl Space Structure: Crawl Space Foundation - There was not visible evidence of significant or unusual structural movement to the crawl space foundation walls. Suggest monitoring.

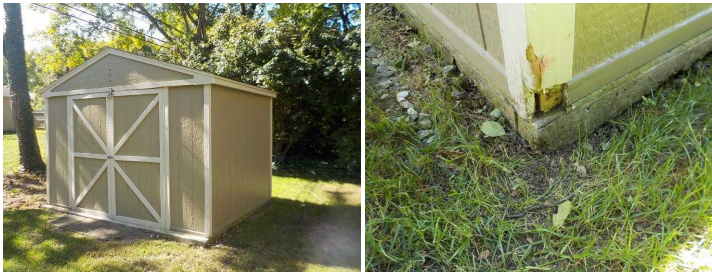
Maintenance Exterior Surface: There is contact between the siding and the ground/mulch. This increases the risk of insect or moisture damage. Suggest eliminating the contact. There is minor scattered peeling paint. Suggest painting as needed.

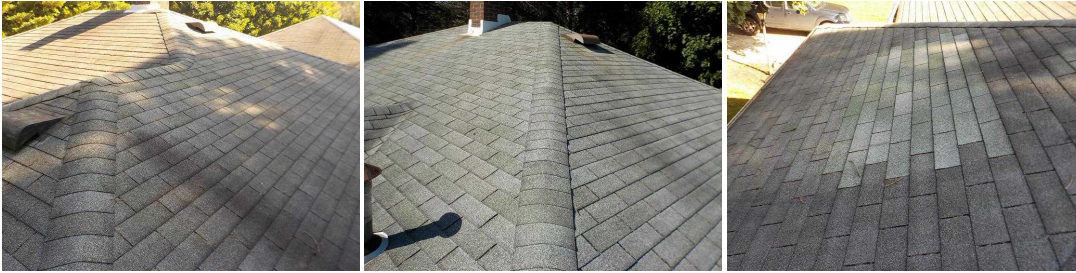
Roof Surface Material: Asphalt/Fiberglass Shingles - The roof covering is generally showing heavy wearing and extending past its typical life. Some heavy sanding has occurred and there are two missing shingle tabs. If leaks are not occurring at this time, it is in a condition where leaks could develop. We suggest further review by a roofing contractor. Due to age and wearing visible, roof replacement may be needed.

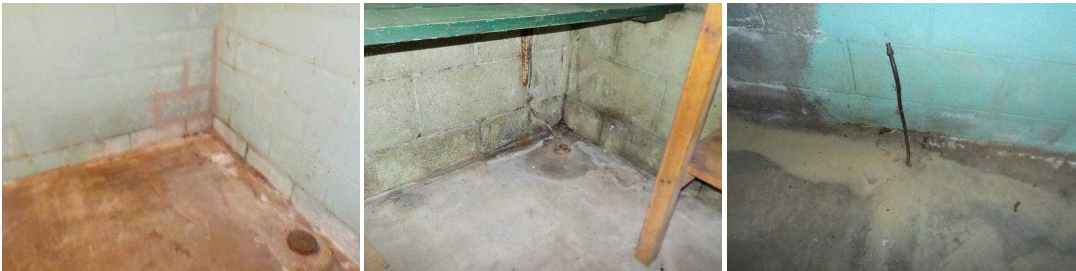
Moisture: The inspection for wetness in the foundation was limited due to: stored items, finishes, disclosure sheet not available, owner not available to question, not being an excessively wet period. There are stains evident on the foundation walls that indicates water leakage may be occurring. Improvements to the spouting drainage, ground drainage, and keeping up with exterior maintenance may help reduce this. However if a completely dry foundation is desired, a professional waterproofing system may need installed. Suggest further review by a waterproofing company.

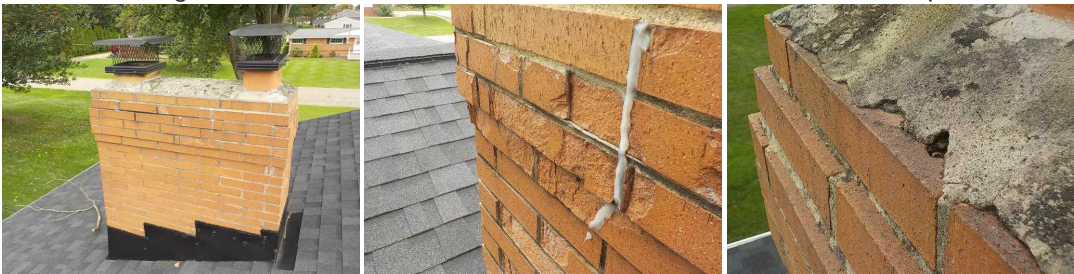
Brick Chimney Chimney: The concrete cap on the top of the chimney has cracking/deterioration. Suggest sealing the cracks or patching the concrete cap as needed to help prevent water entry and damage to the top of the chimney. Some spalling has occurred to brickwork at the top of chimney. This is likely caused by water entering and flaking off the front surface of the bricks. The brickwork could be patched/sealed as needed.

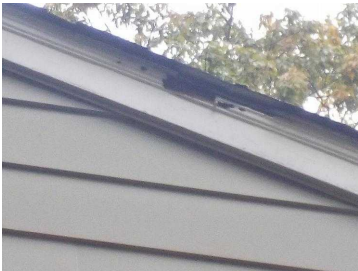
Trims: There is rotting/deterioration to the fascia board on the south side of the house. Animals/birds could enter. Suggest repairing as needed.
